**LEE COUNTY BLIND PASS RESTORATION PROJECT
1-YEAR MONITORING REPORT**

**February 21, 2011
CEC File No. 10.058**

This monitoring information is submitted in accordance with Specific Condition No. 45 of the approved Physical Monitoring Plan for Permit No. 0265943-001-JC for the monitoring period August 2009 through October 2010.

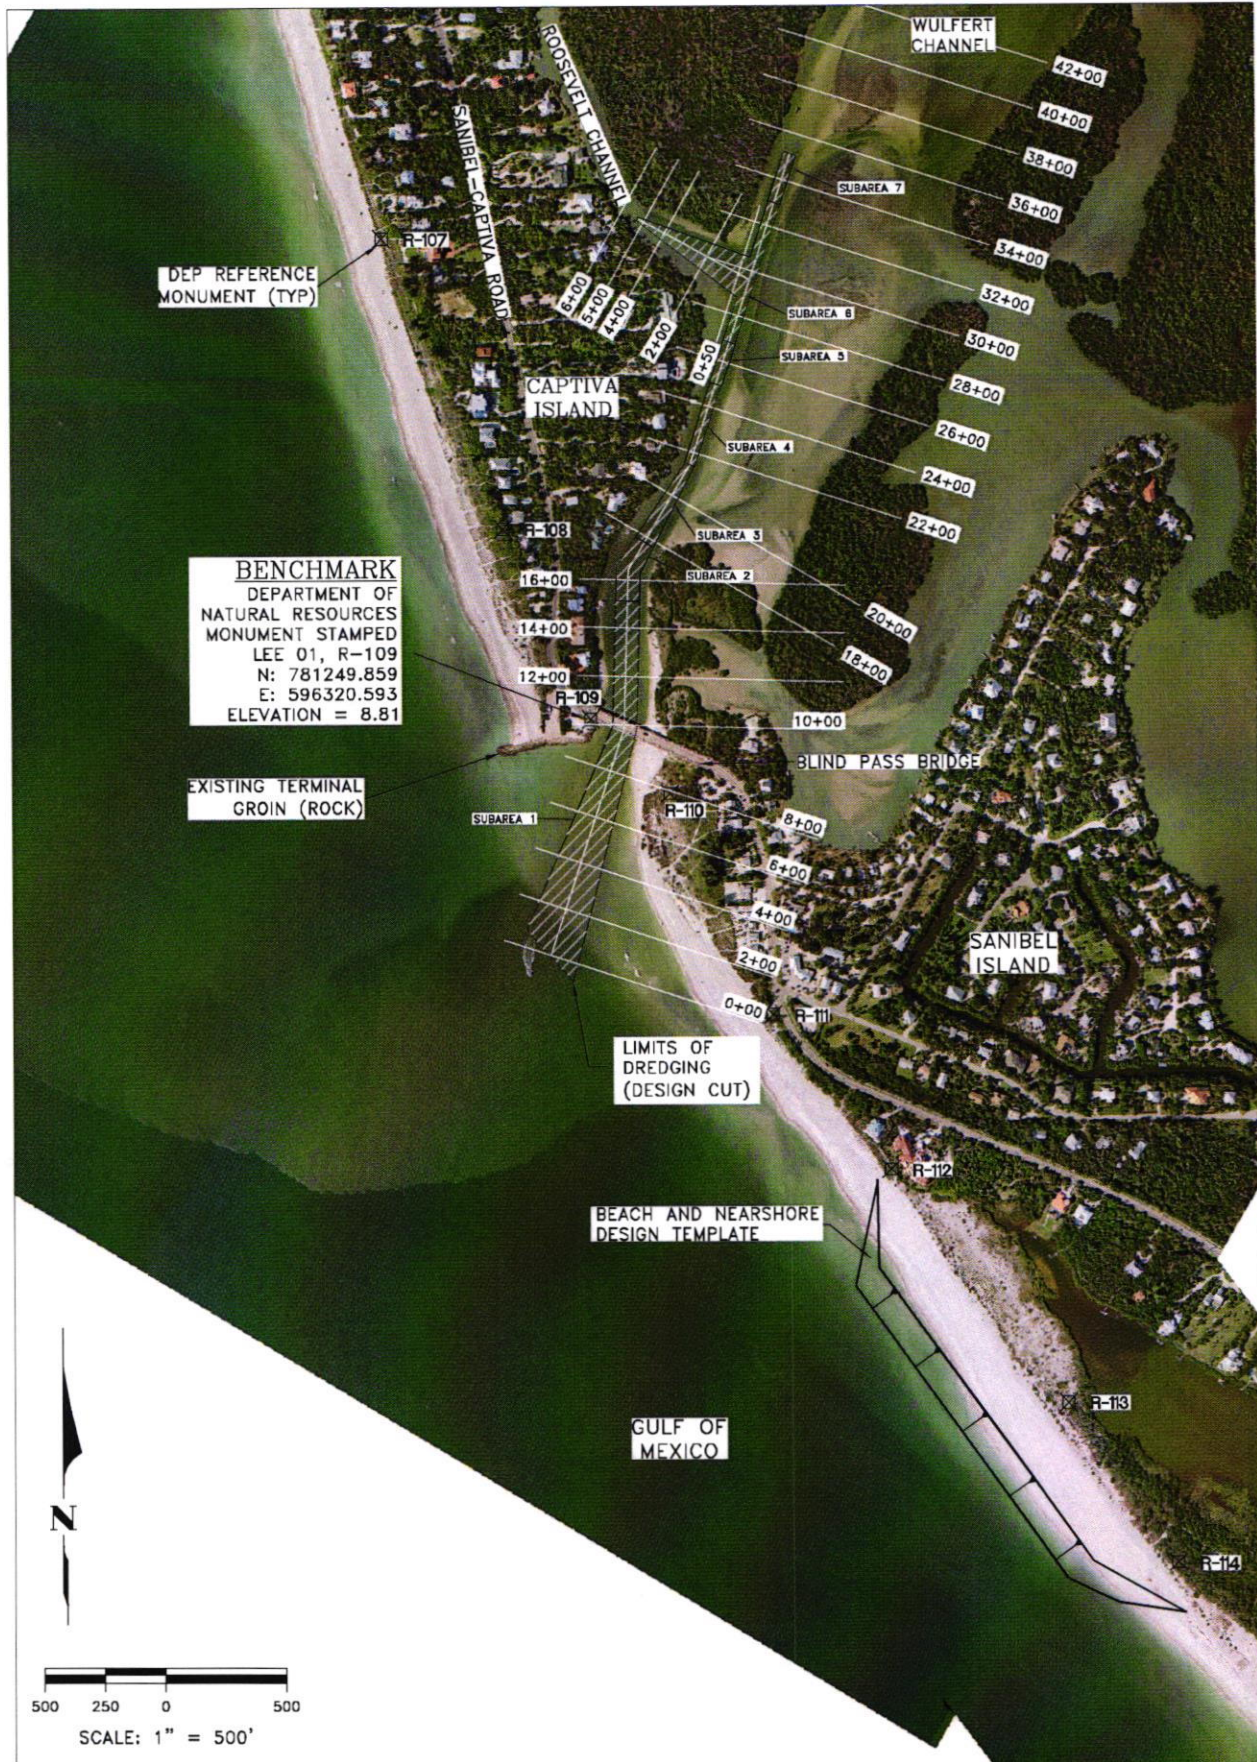
CLIENT: LEE COUNTY BOARD OF COMMISSIONERS
 TITLE: **FIGURE 1
 BLIND PASS LOCATION MAP**

In 2009, Lee County completed construction of the Blind Pass restoration project by opening previously closed Blind Pass. A location map of the project area is presented in Figure 1. This report summarizes the results of the post-construction and first year physical monitoring surveys. The work was performed by Coastal Engineering Consultants (CEC). Funding for the monitoring and report was provided by the Florida Department of Environmental Protection (FDEP), Captiva Erosion Prevention District, and Lee County.

Appendix 4 presents the Blind Pass cross sections surveyed in August 2009 (post-construction) and October 2010 (1-year monitoring). The restoration template and stations are depicted in Figure 1. It should be noted that in some cases the existing boat docks precluded survey data collection to the MHW line.

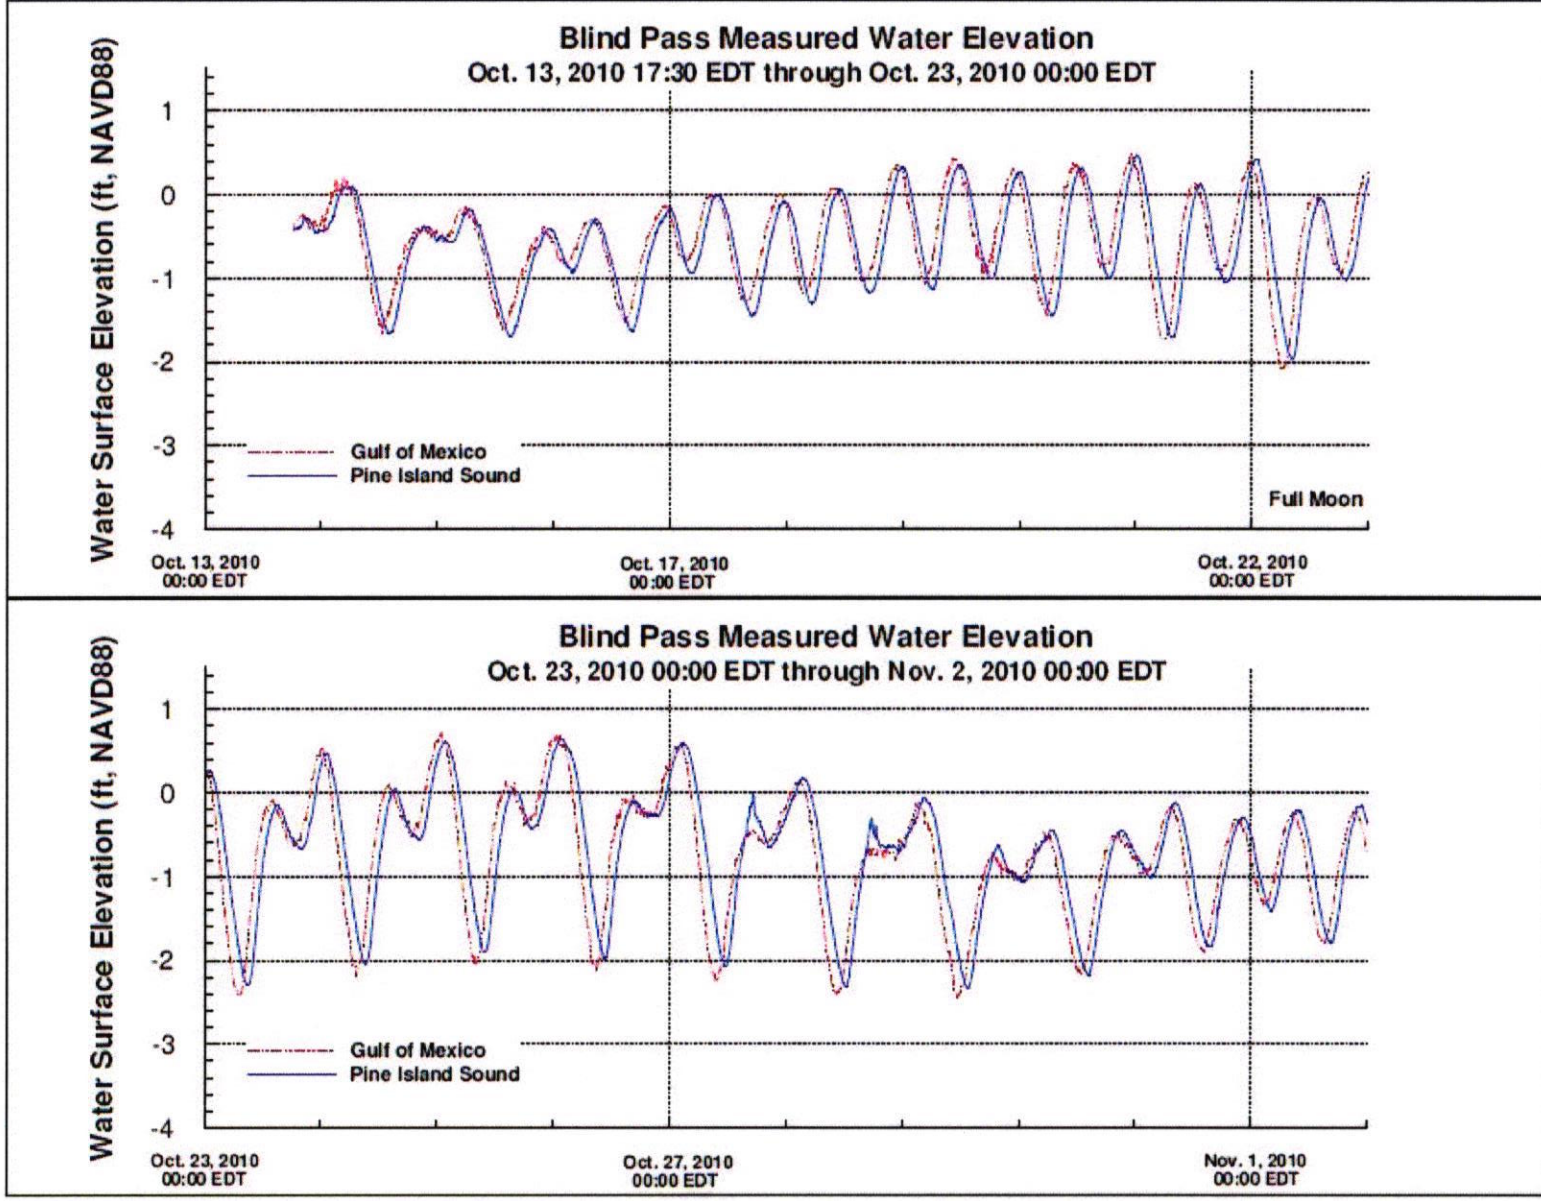
The hydraulic results of the monitoring event are shown below in Figures 6 through 9. A new moon was observed on November 6, 2010 and a full moon occurred on October 23, 2010. The measured tidal range on the Gulf of Mexico side was 3.6 feet and 2.7 feet during the new moon and full moon, respectively; the maximum tidal range, 4.4 feet, occurred on November 5, 2010. According to the meteorological data obtained from NOAA's station in Venice, Florida, on that day the wind blowing from north-north-west reached speeds up to 27 mph. In Pine Island Sound, the tidal ranges during the new moon and full moon were 3.0 feet and 2.5 feet, respectively; the maximum tidal range, 3.3 feet, occurred on November 5, 2010. The average phase lags between

the two locations were approximately 80 minutes and 115 minutes for the peak flood tide and peak ebb tide, respectively. The maximum current velocity in Wulfert Channel, 5.3 feet/sec, occurred on November 5, 2010. The average peak velocities over a 33-day period between October 13, 2010 and November 15, 2010 were 1.3 feet/sec and 1.1 feet/sec for the flood and ebb tidal phases, respectively.

FIGURE 6
WATER SURFACE ELEVATIONS MEASURED BETWEEN OCTOBER 13 AND
NOVEMBER 2, 2010 IN GULF OF MEXICO AND PINE ISLAND SOUND

The maximum tidal ranges measured between October 13 and November 15, 2010 in the Gulf of Mexico and Pine Island Sound were 4.4 feet and 3.3 feet, respectively. The maximum current velocity measured at Blind Pass during this period was approximately 5.3 feet/sec. These conditions occurred on November 5, 2010 as a result of strong wind from north-northwest that reached speeds up to 27 mph. After excluding this episodic event, the typical maximum tidal ranges and current velocity were 3.6 feet (Gulf of Mexico), 3.0 feet (Pine Island Sound), and 2.4 feet/sec (Blind Pass).

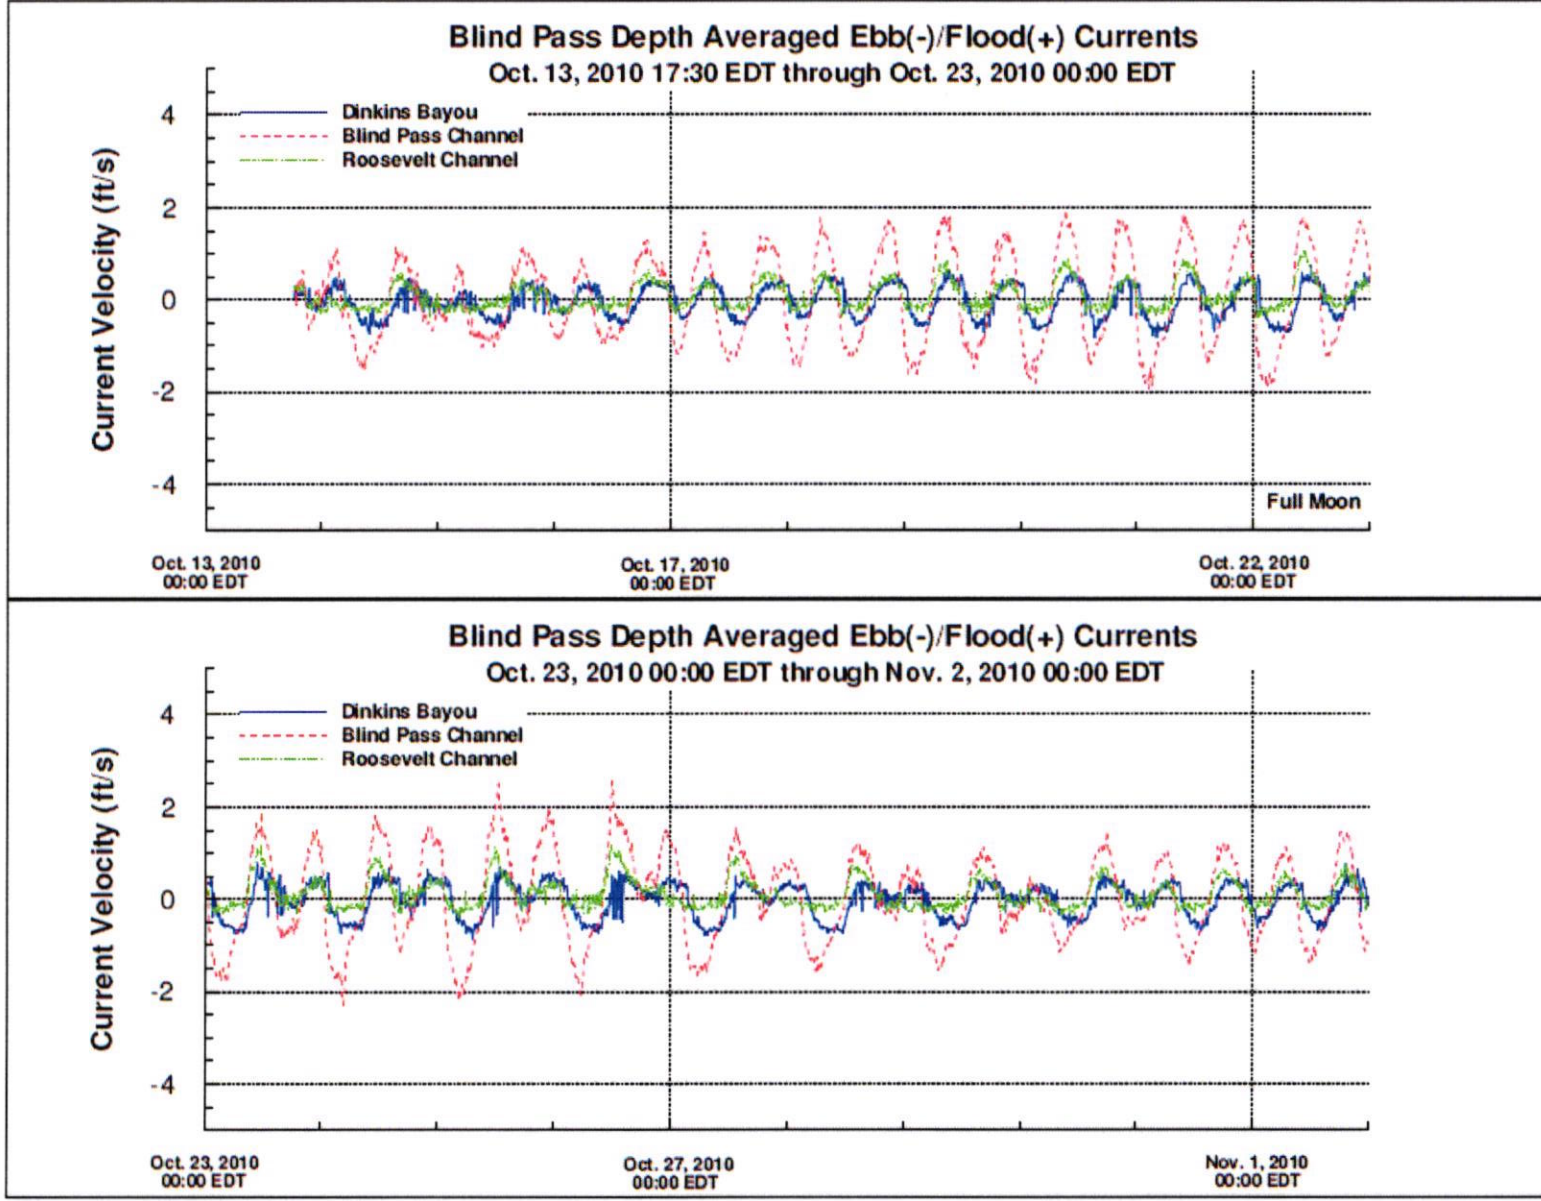
FIGURE 8
DEPTH AVERAGED CURRENT VELOCITIES MEASURED BETWEEN OCTOBER 13
AND NOVEMBER 2, 2010 IN BLIND PASS CHANNEL, DINKINS BAYOU, AND
ROOSEVELT CHANNEL

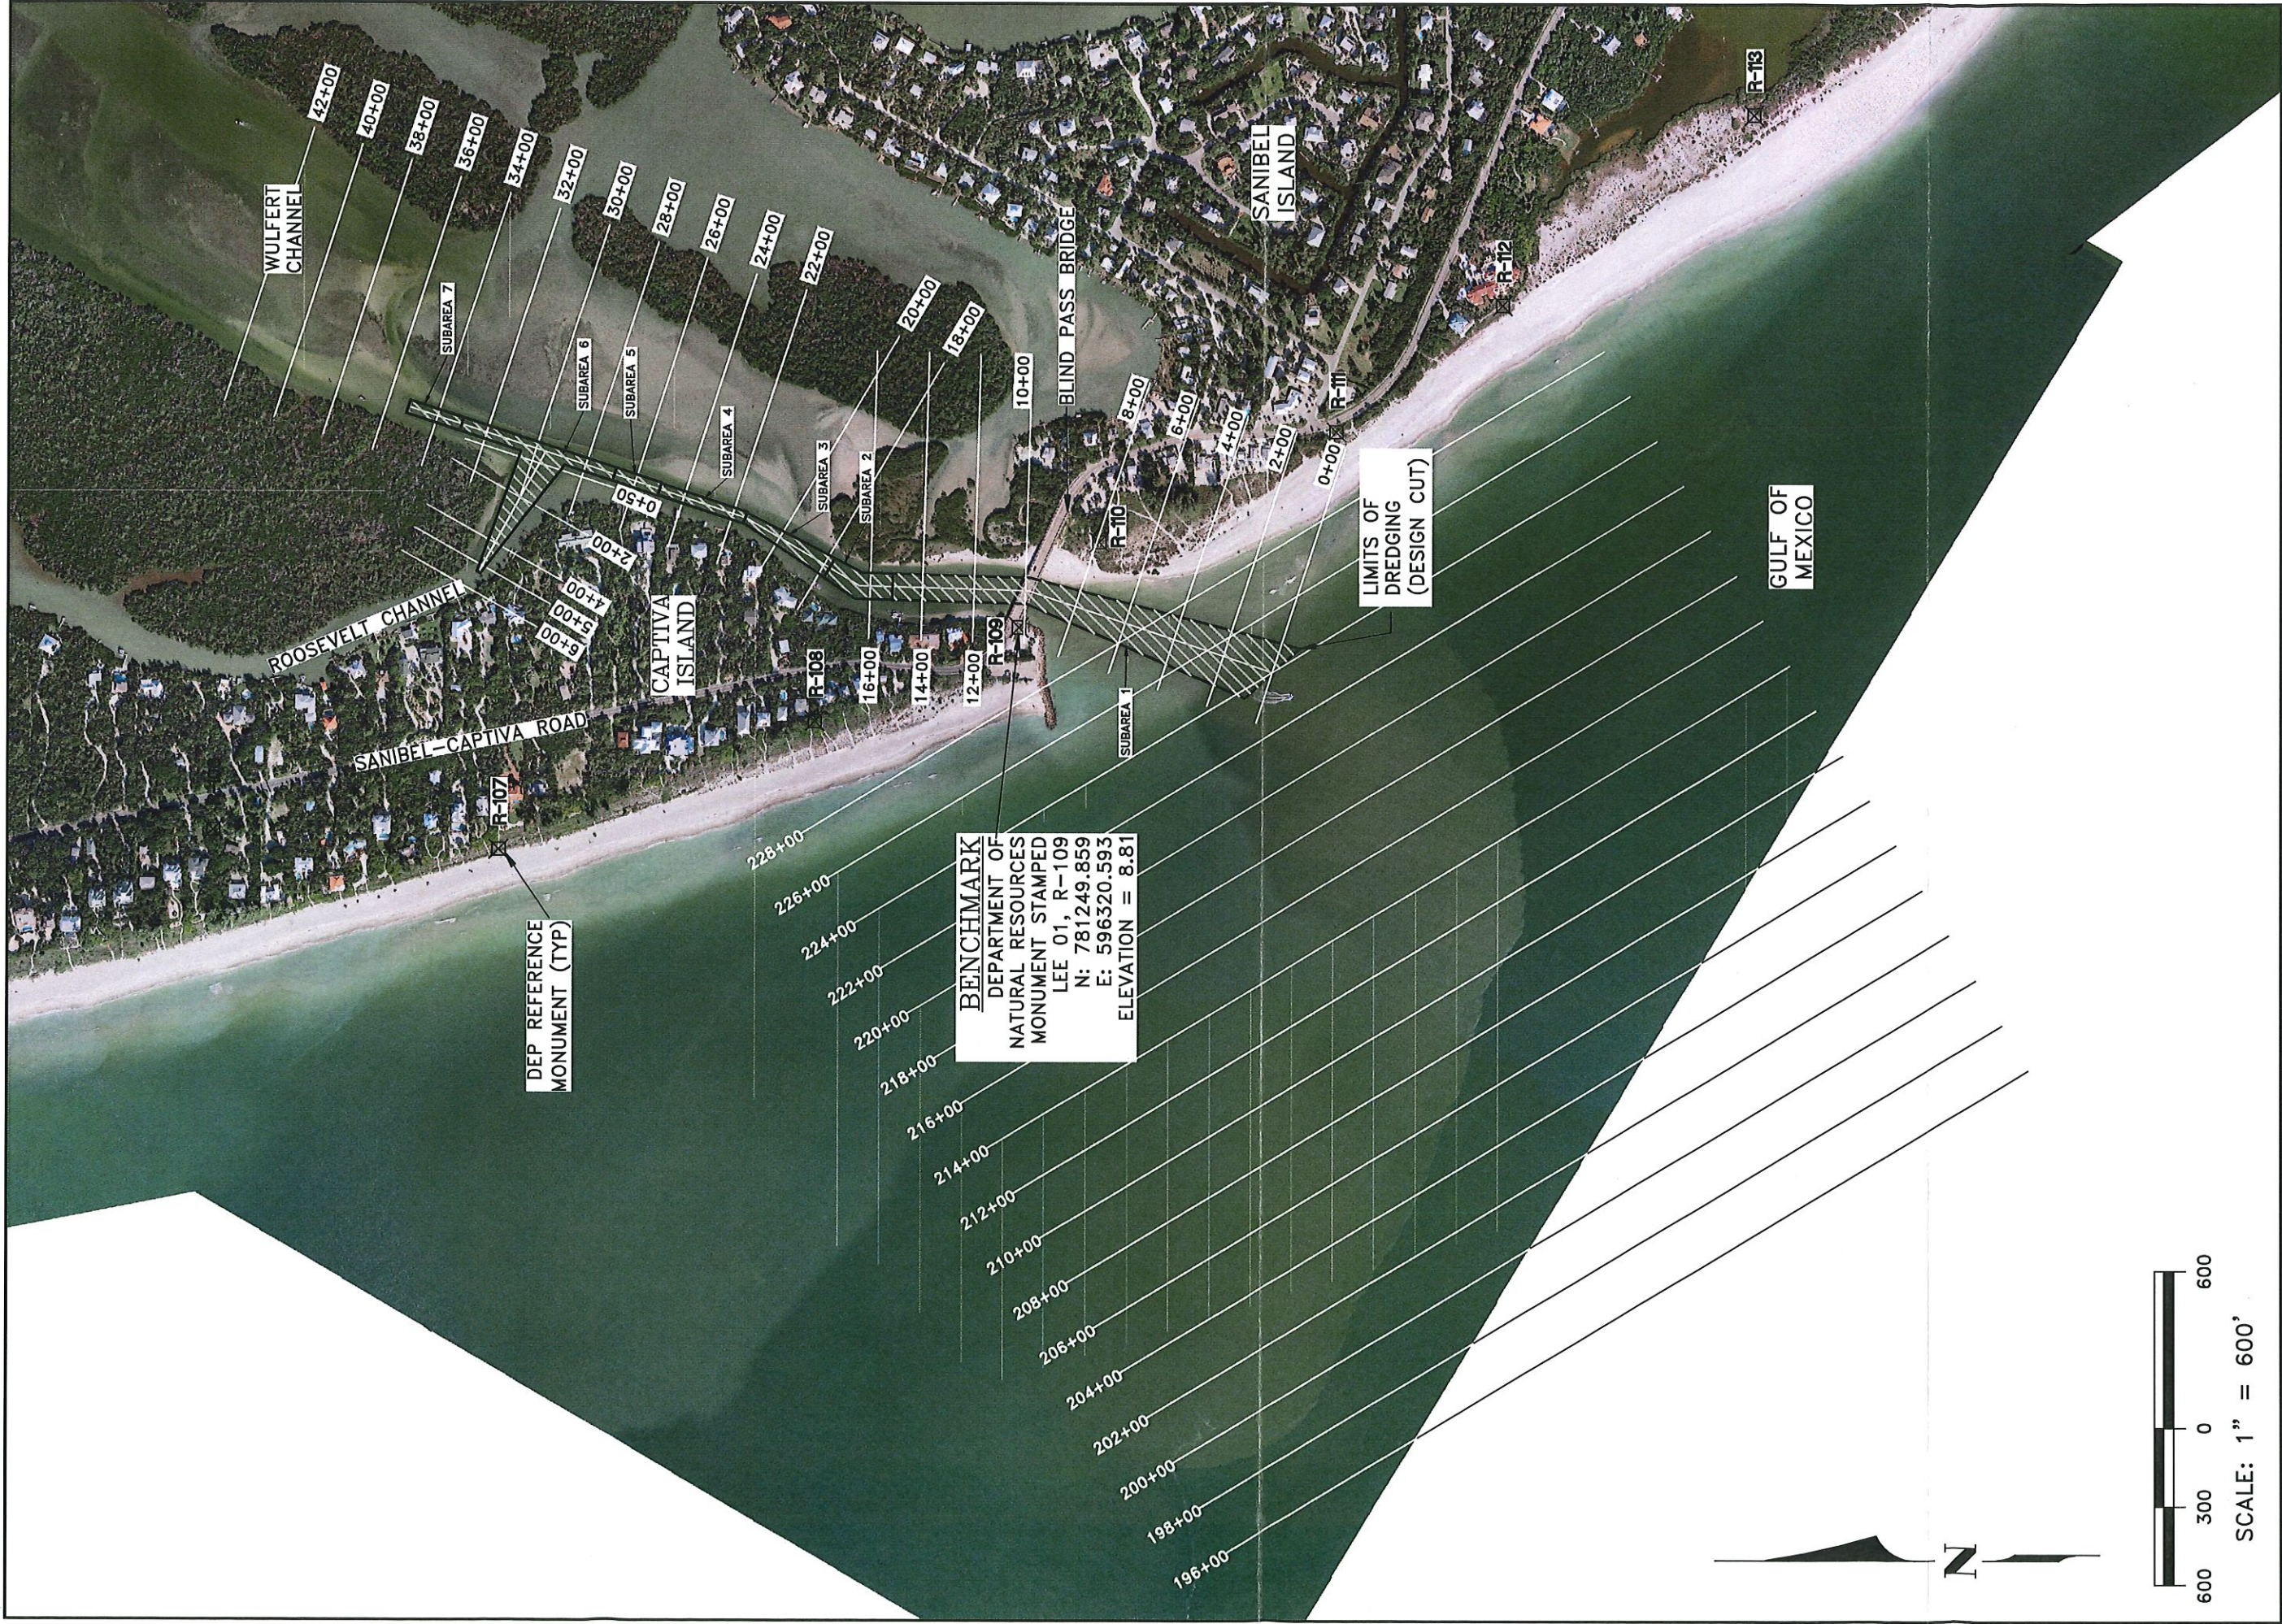
BLIND PASS AND EBB SHOAL CROSS SECTIONS

DEP REFERENCE MONUMENT (TYP)

BENCHMARK
 DEPARTMENT OF
 NATURAL RESOURCES
 MONUMENT STAMPED
 LEE 01, R-109
 N: 781249.859
 E: 596320.593
 ELEVATION = 8.81
