**REDFISH PASS INLET MANAGEMENT PLAN**

**Captiva Erosion Prevention District**

**Coastal Planning & Engineering, Inc.  
2481 NW Boca Raton Boulevard  
Boca Raton, FL 33431**

**August 1995**

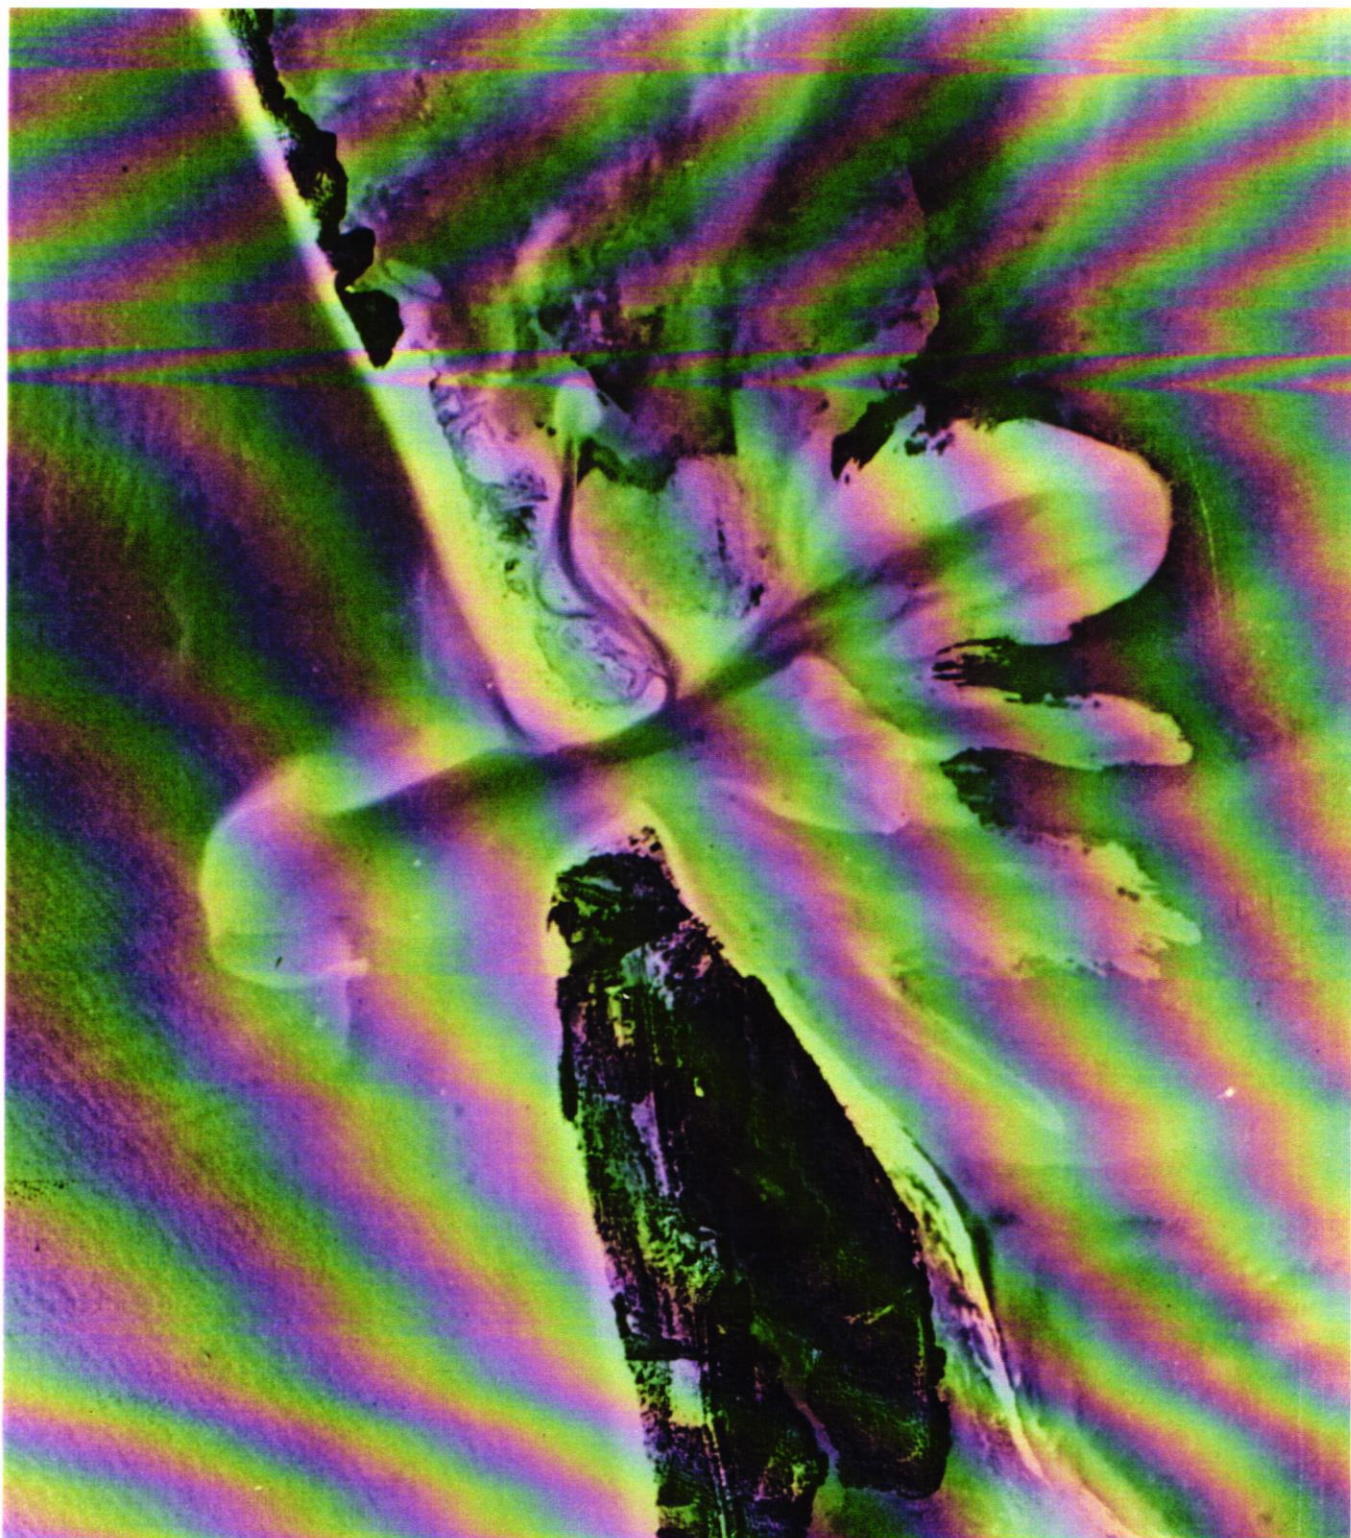
Photo No. 1: Aerial view of Redfish Pass (2/11/44).

Note the visibility of both flood and ebb shoals, and the recurved spit on North Captiva extending inward toward Pine Island Sound.

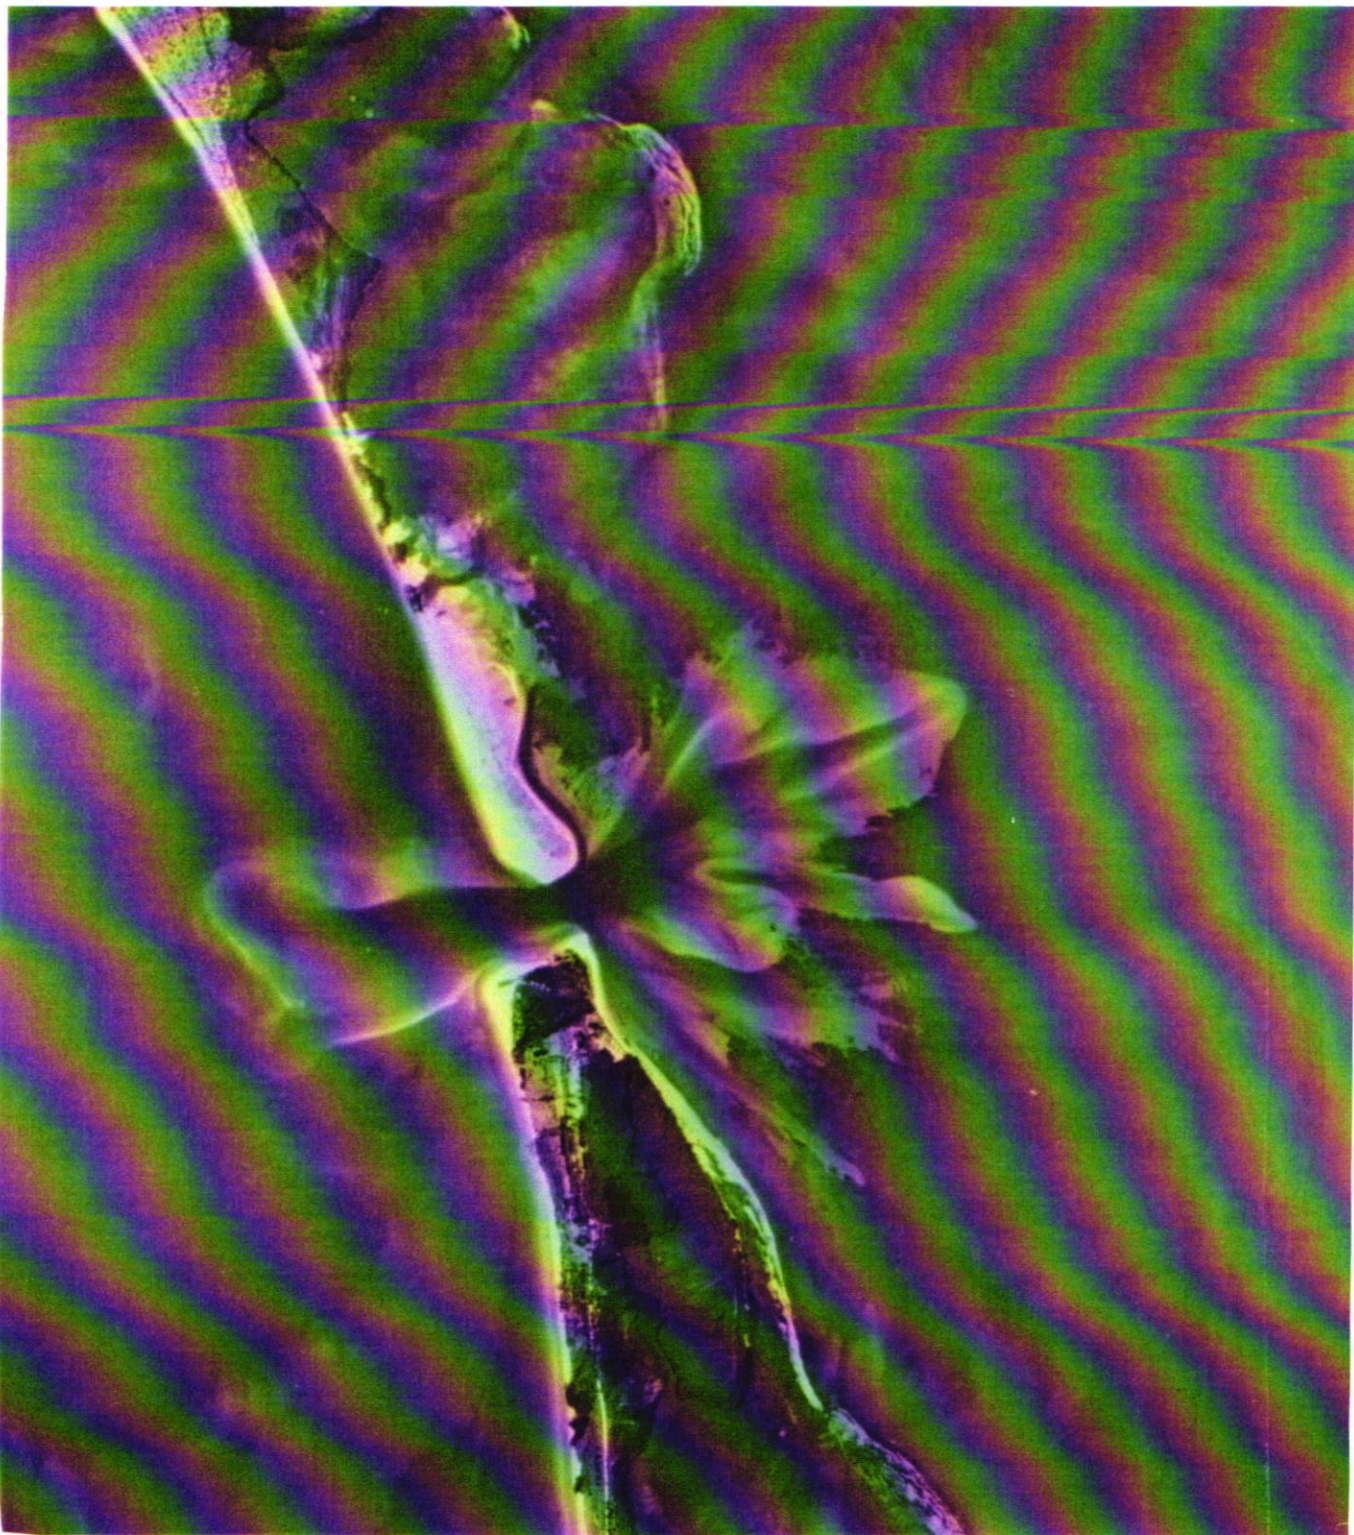
Photo No. 2: Aerial view of Redfish Pass (5/5/52).

Note the erosion of the southern tip of North Captiva Island  
and the northern section of Captiva Island.

Photo No. 2, an aerial view of the Redfish Pass area, was taken in May 1952. Note that the inlet channel has become wider and more defined.

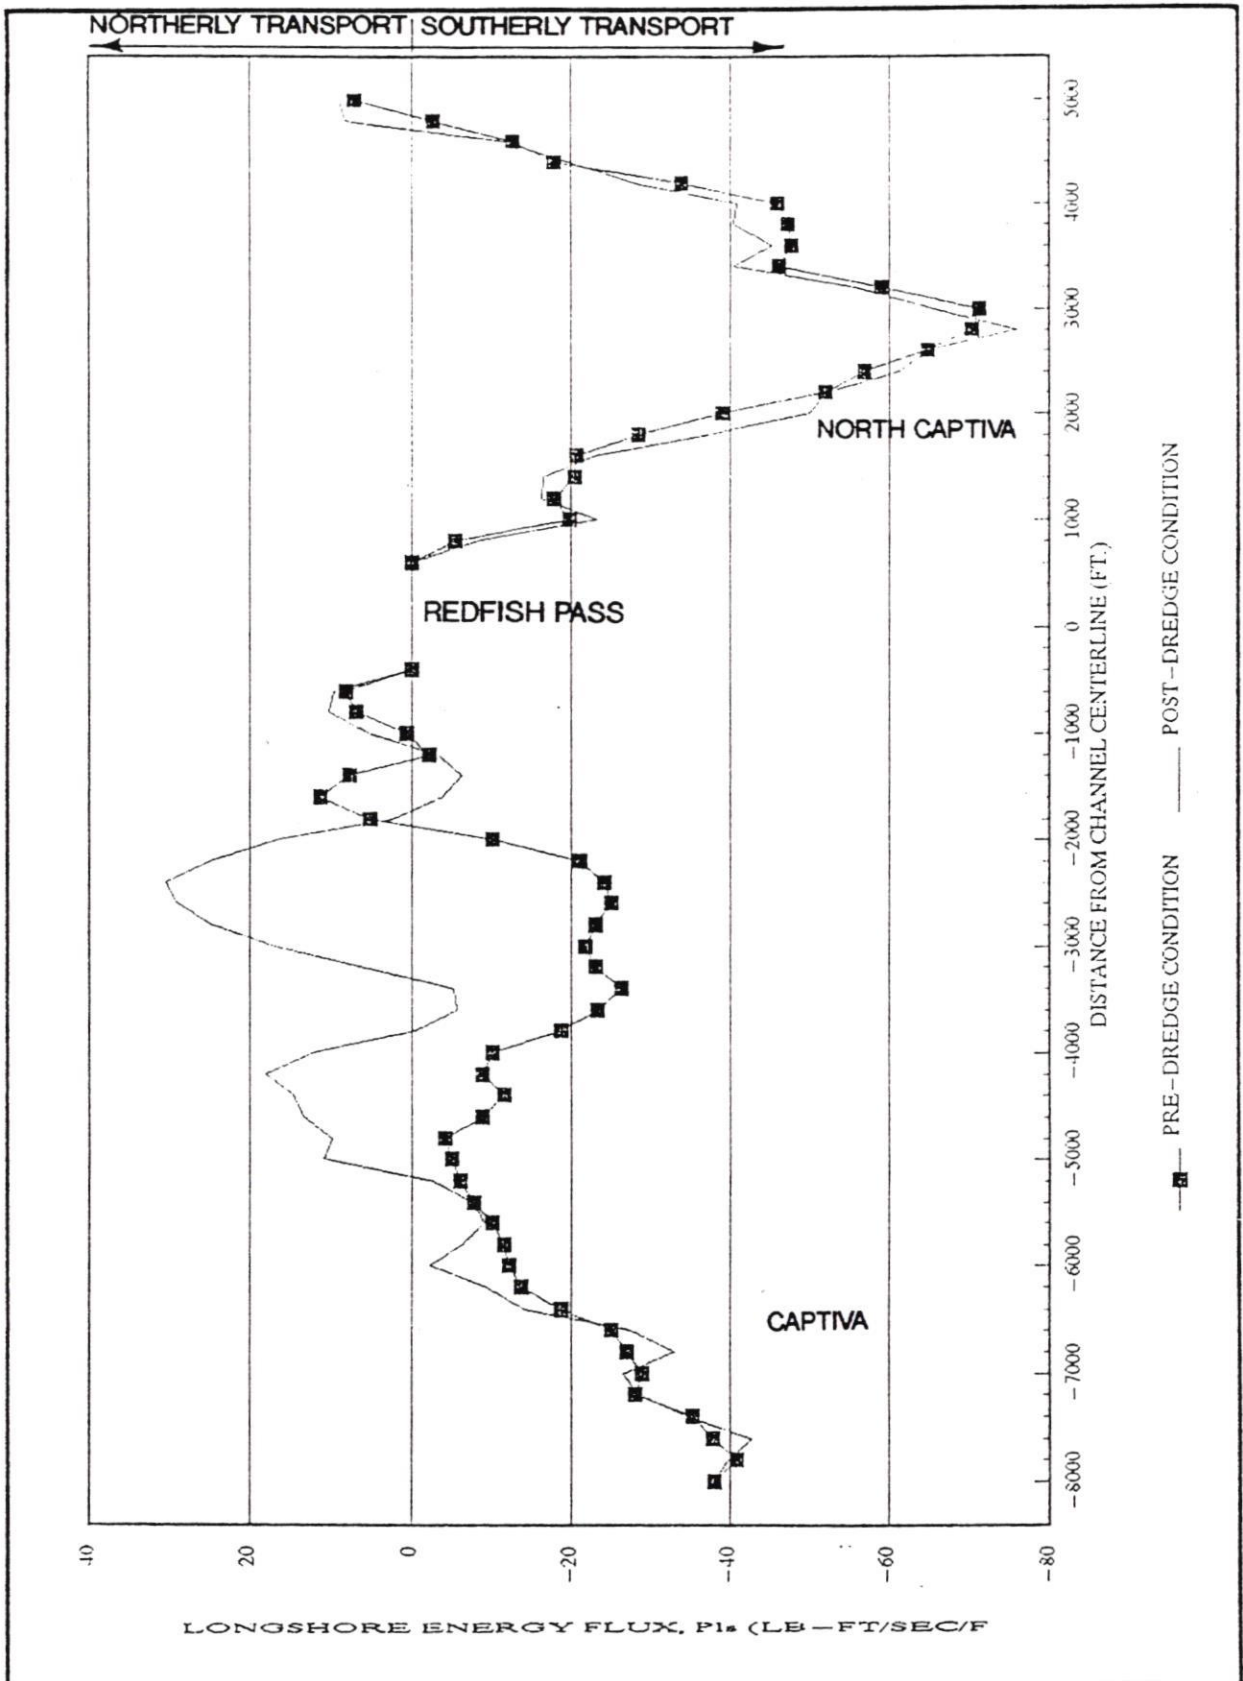
FIGURE G10

1988 PRE-DREDGING AND  
 1991 POST-DREDGING CONDITIONS  
 LONGSHORE TRANSPORT POTENTIAL  
 FOR SHORELINES ADJACENT TO REDFISH PASS
